Technical Bulletin

| Number: | MTFW-09-99 |
| Model: | 317 |
| Subject: | Printhead failures and label application |

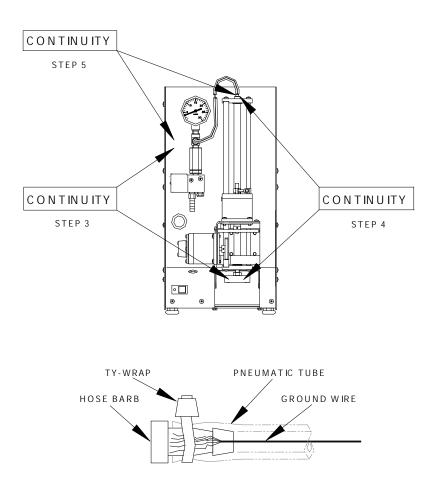
Figure 1

Static has been found to be a significant cause of printhead failures. A good ground path from the applicator head to the machine frame effectively dissipates the static generated by the separation of the labels from the liner.

- 4. Check for continuity between the applicator head and the machine frame (See figure 1). If continuity does not exist go to step 5.
- 5. Check for continuity between the applicator head and the hose barb on the top of the pinion wire (See figure 1). If continuity exists, proceed to step 6. If continuity does not exist, install KOP 83047200A and proceed to step 6.

- 6. Check for continuity between the machine frame and the hose barb at the top of the pinion wire (See figure 1). If there is no continuity, correctly install the ground wire from the vacuum gauge through the vacuum hose to the hose barb on the top of the pinion wire (See figure 1).
