# Technical Bulletin

**Number: MTFW-12-00**  
**Date: 05-11-00**  
**Model: 317**  
**Subject: Applicator Information**

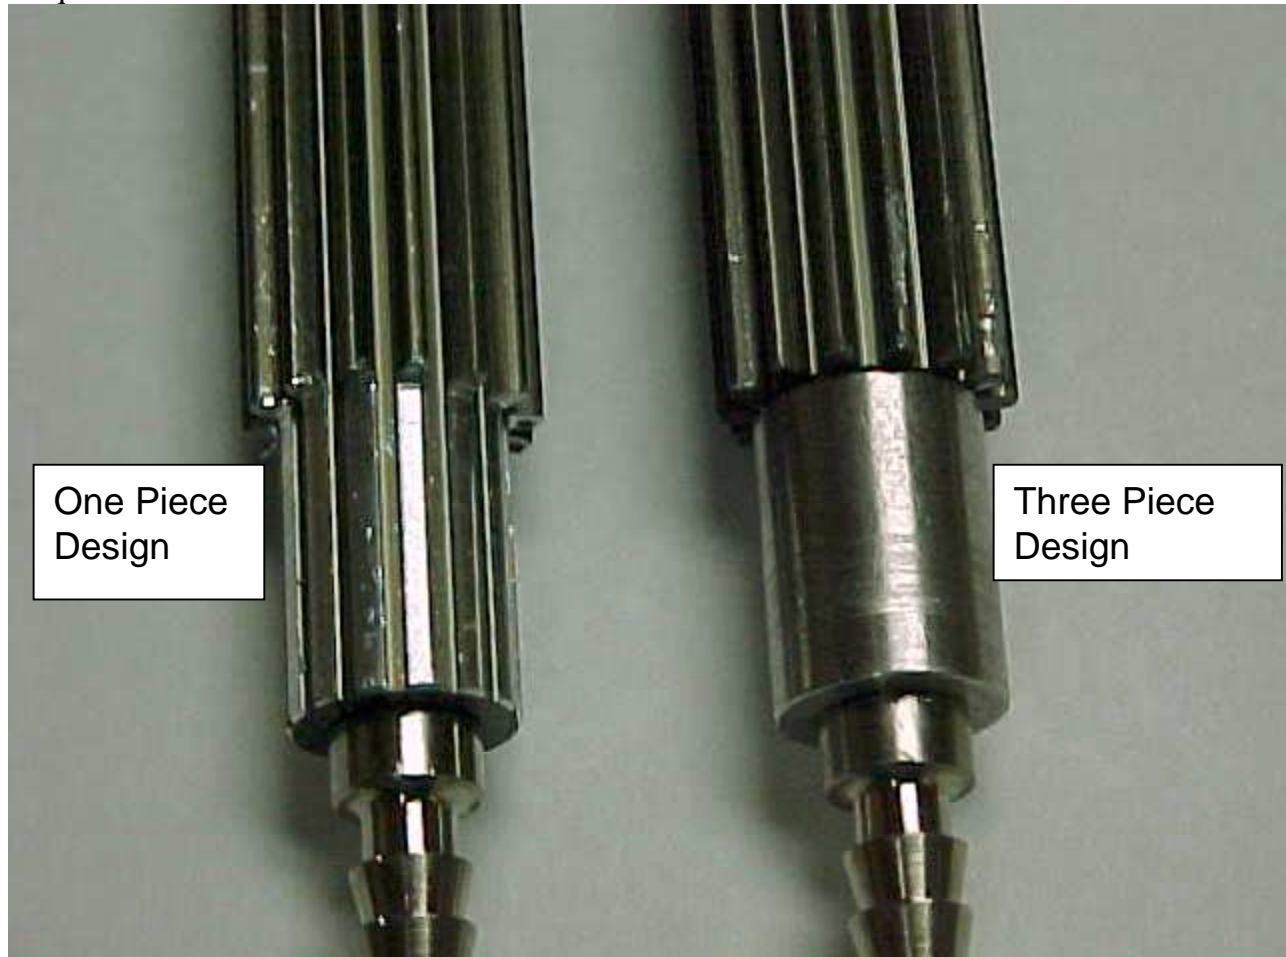
The applicator pinion wire (P/N 82807700A) was changed on 4/1/98 from a one-piece design to a three-piece design for manufacturing purposes. Two problems that developed from this are that the concentricity of these pinion wire assemblies varied greatly from one part to another which created binding in the applicator assembly on some units and some instances of the pressed inserts falling out.

A one piece pinion wire (P/N B82807700A) was put into production on all 317 applicator printers built after 2/23/00 and beginning with S/N 3089545-3BB. The threaded end and bearing surfaces are machined into the part. This pinion wire holds its concentricity and straightness to within .010" and does not require inserts.

Insert separates from the pinion wire.	Replace pinion wire with B82807700A.
No continuity through the pinion wire.	Replace pinion wire with B82807700A.

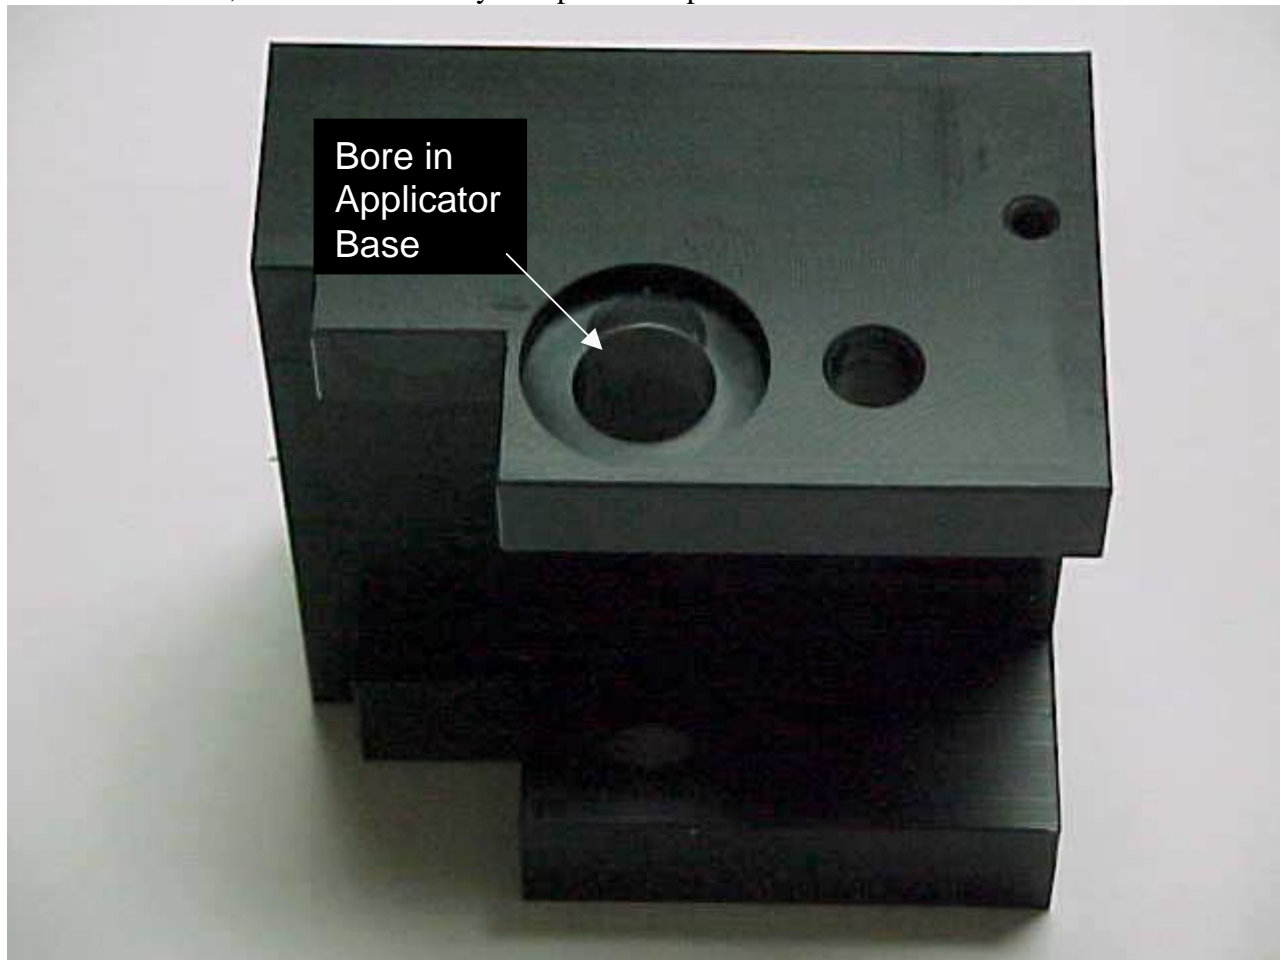
Two issues had been found with the applicator base.

- In very cold environments a tolerance stackup between the applicator base and the pinion wire combined with the material properties of the applicator block can cause a binding condition with the pinion wire. On units built after 1/12/00 beginning with S/N 3088917-3AB the bore of the applicator base was opened to allow for the shrinkage.
- Over time, we have found that the pinion wire will wear grooves in the bore of the applicator base, which may create a catch when trying to turn the pinion wire. This is a bearing surface. If this condition occurs, it will be necessary to replace this part.
