Technical Bulletin

Mettler-Toledo, Inc.
Scales & Systems

Number: MTFW-13-00
Date: 05-15-00
Model: 645
Subject: Center Clamp Errors

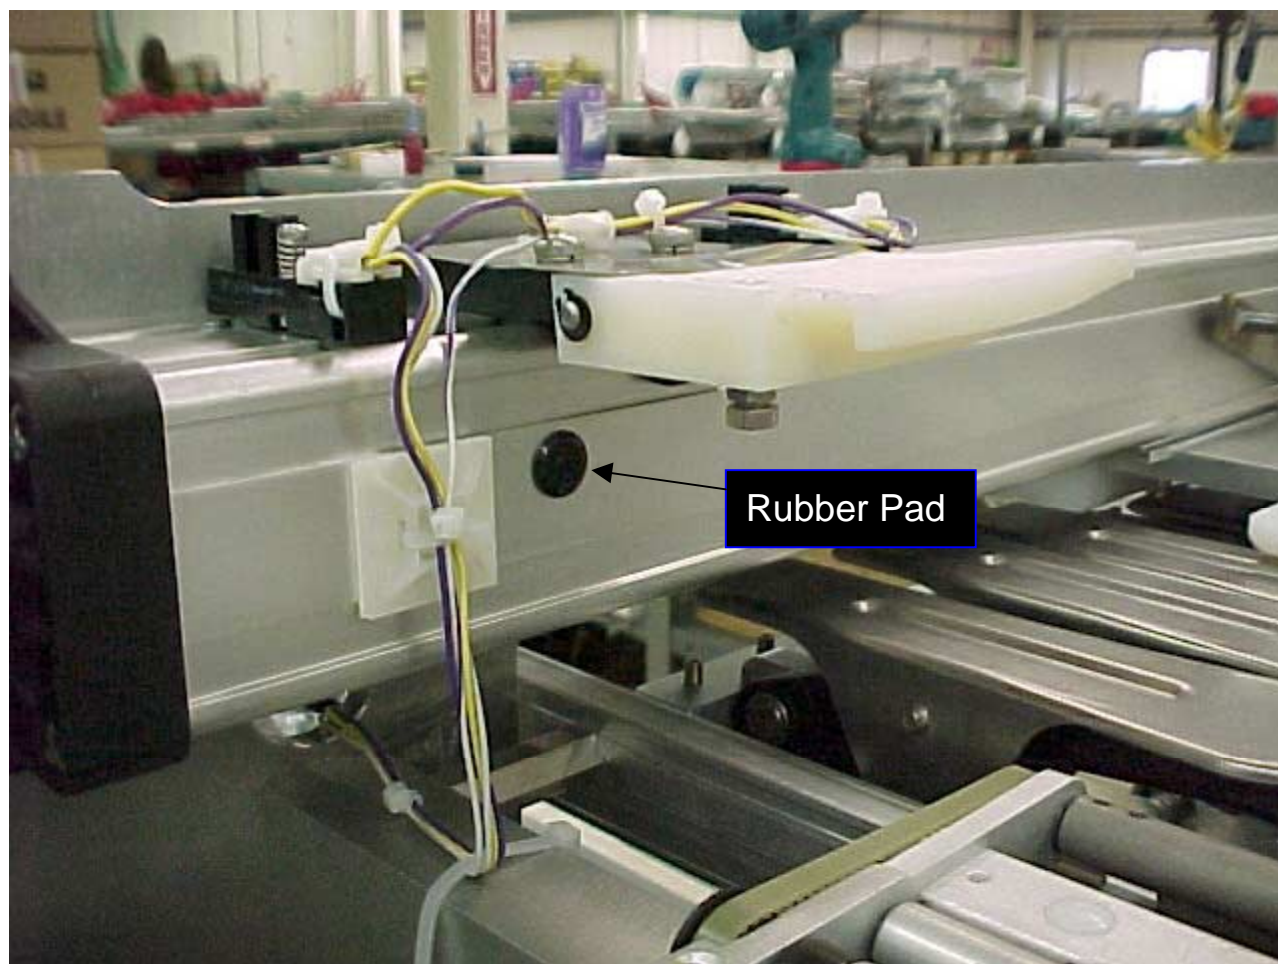
We have found a number of occurrences of the rubber pad on the center clamp actuator casing (shown below) falling off. This can cause the center clamp cam to get out of adjustment and the pin on the center clamp actuating lever to get caught on the cam as the center clamp pulls back from the distributor. Beginning with S/N 3090619-3EB the pad has been removed and the adjusting screw has been readjusted to the proper position. If you are having occurrences of center clamp related errors check for the absence of this rubber pad. If it is missing, adjust the stop screw to compensate.

We recommend that you remove this pad and readjust the cam position on your next PM visit.

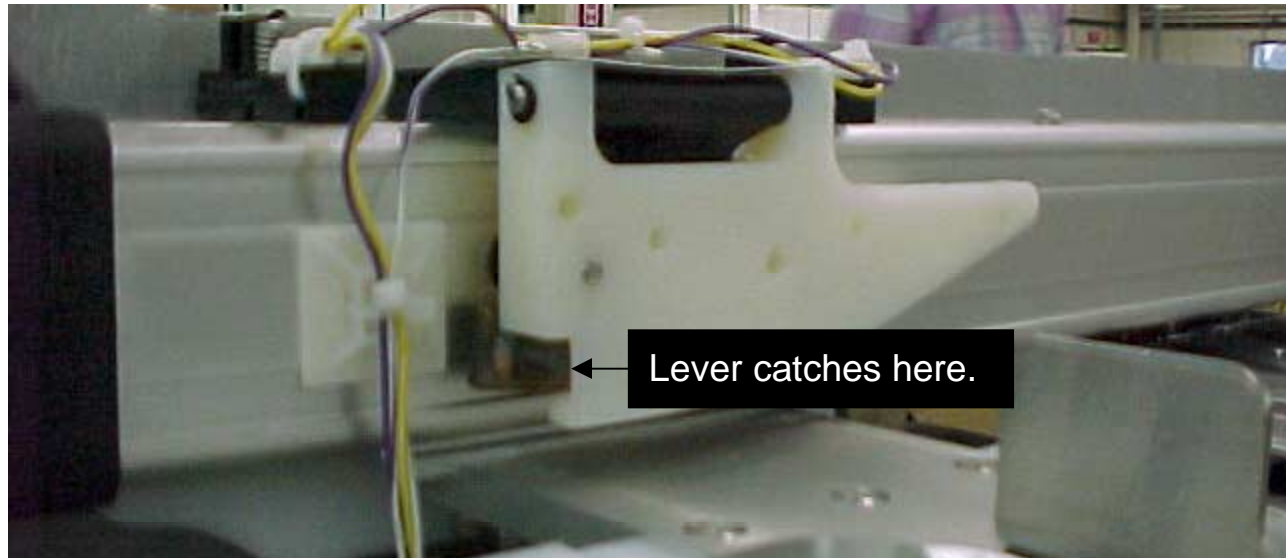
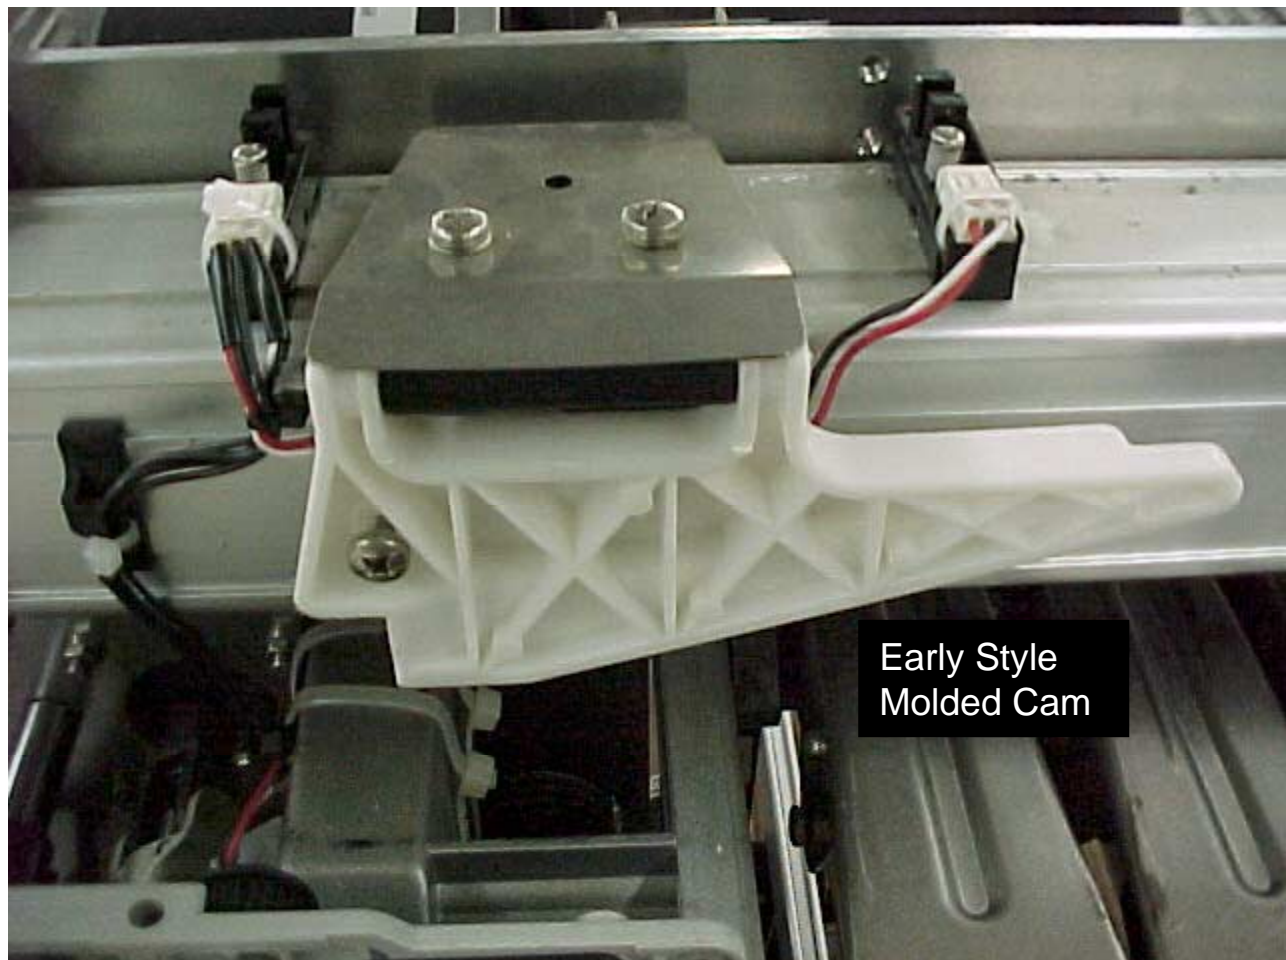
Early machines with the molded cam are not affected. They can be identified by the hollow area on the outside of the cam and the exposed screw head.
