Technical Bulletin

Mettler-Toledo, Inc.
Scales & Systems

Number: MTFW-14-00
Date: 05-15-00
Model: 645 Plus
Subject: Film Folders Binding

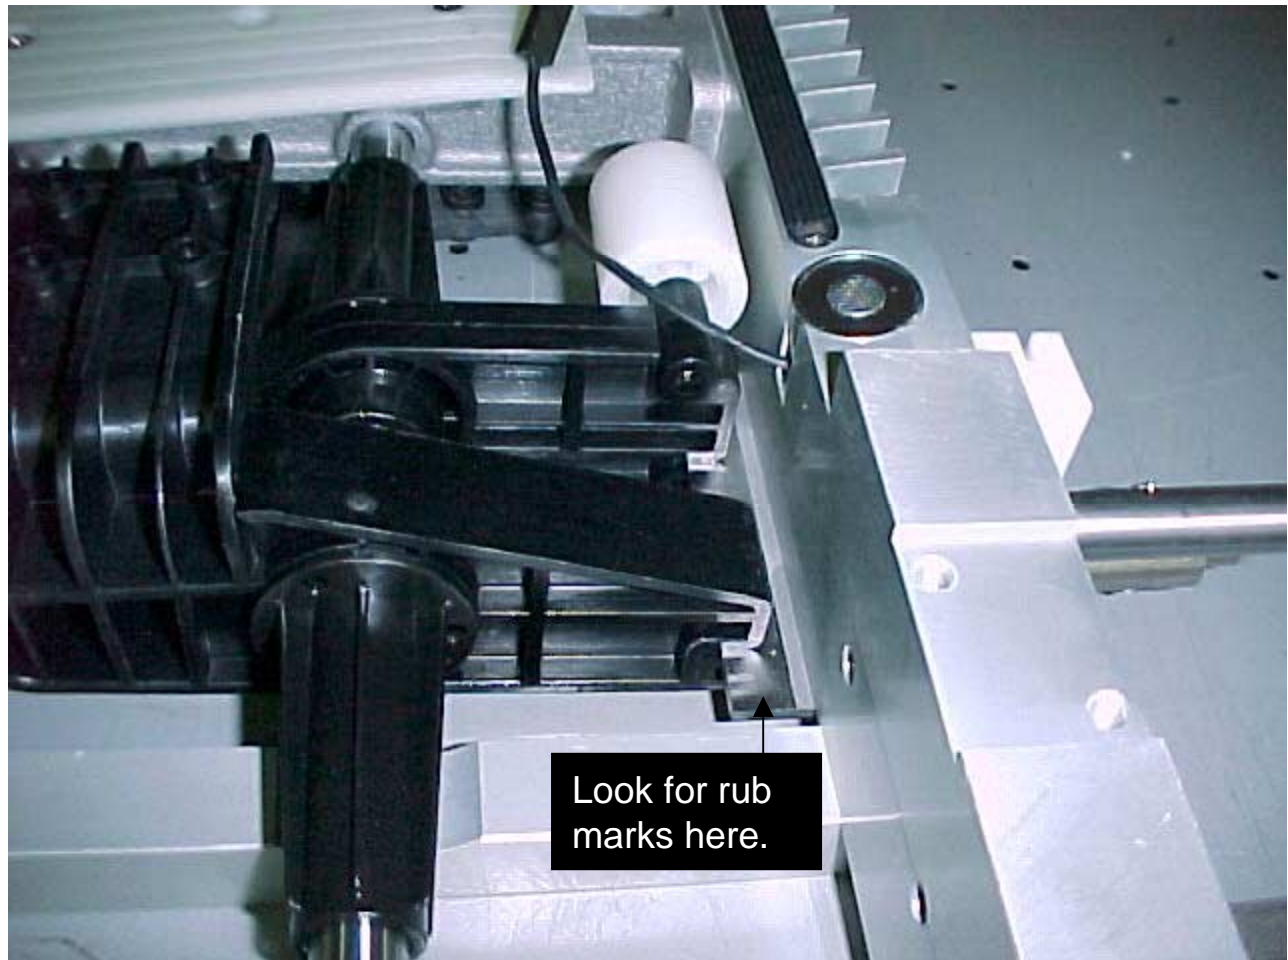
A potential binding condition has been found in the film folder assembly on the 645 Plus. There is a tight clearance between the film folder support assembly and the film folder guide plate located on the bottom of the distributor assembly. If the folder support rubs or drags on the guide plate it may cause the folder motor to stall and display an error 52, 53 or 54. If you have a machine displaying these conditions, lift the sealing belt and look for rub marks on the film folder guide plates. If rub marks are displayed, replace the guide plates with P/N 82731800A. The replacement plates will have a step machined into them. This stepped surface should be facing up when installed to provide the proper clearance.
