Technical Bulletin

Mettler-Toledo, Inc.
Scales & Systems

Number: MTFW-18-00

Subject: Poor Print Quality on Right Side of Label

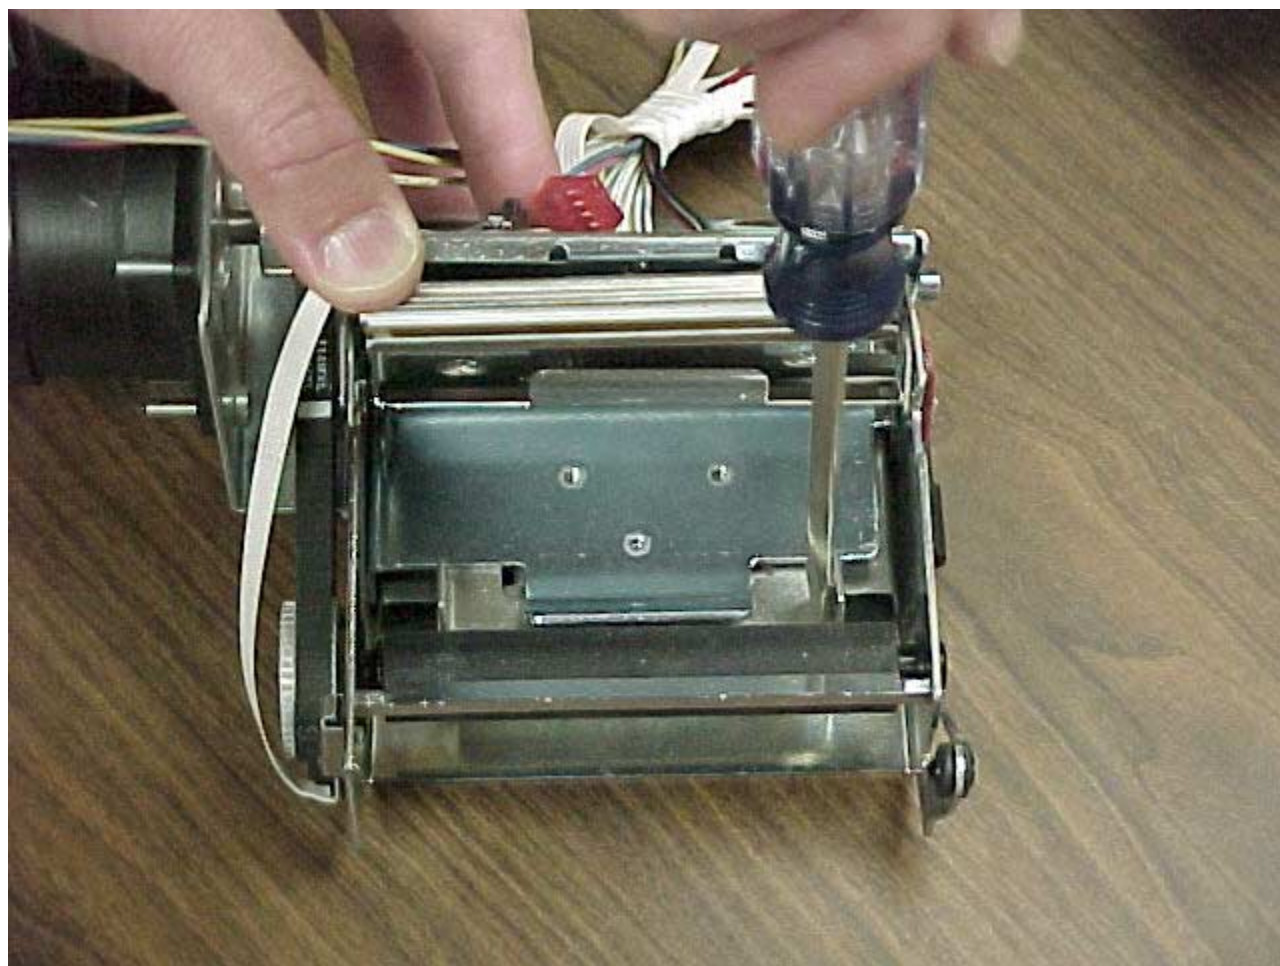
There have been some instances of light or faded print on the right side of the label on new 317 printers. This condition is caused by interference between the label guide and the printhead on the right side. To correct this condition, first lift the cover on the print engine to expose the label guide assembly. Then, using a screwdriver push down on the right side of the label guide assembly bending the guide slightly to provide clearance between the printhead and the guide. See picture below.
