Technical Bulletin

Mettler-Toledo, Inc.
Scales & Systems

Number: MTFW-22-00
Date: 10-09-00
Model: 645
Subject: Motor Isolator Mounts

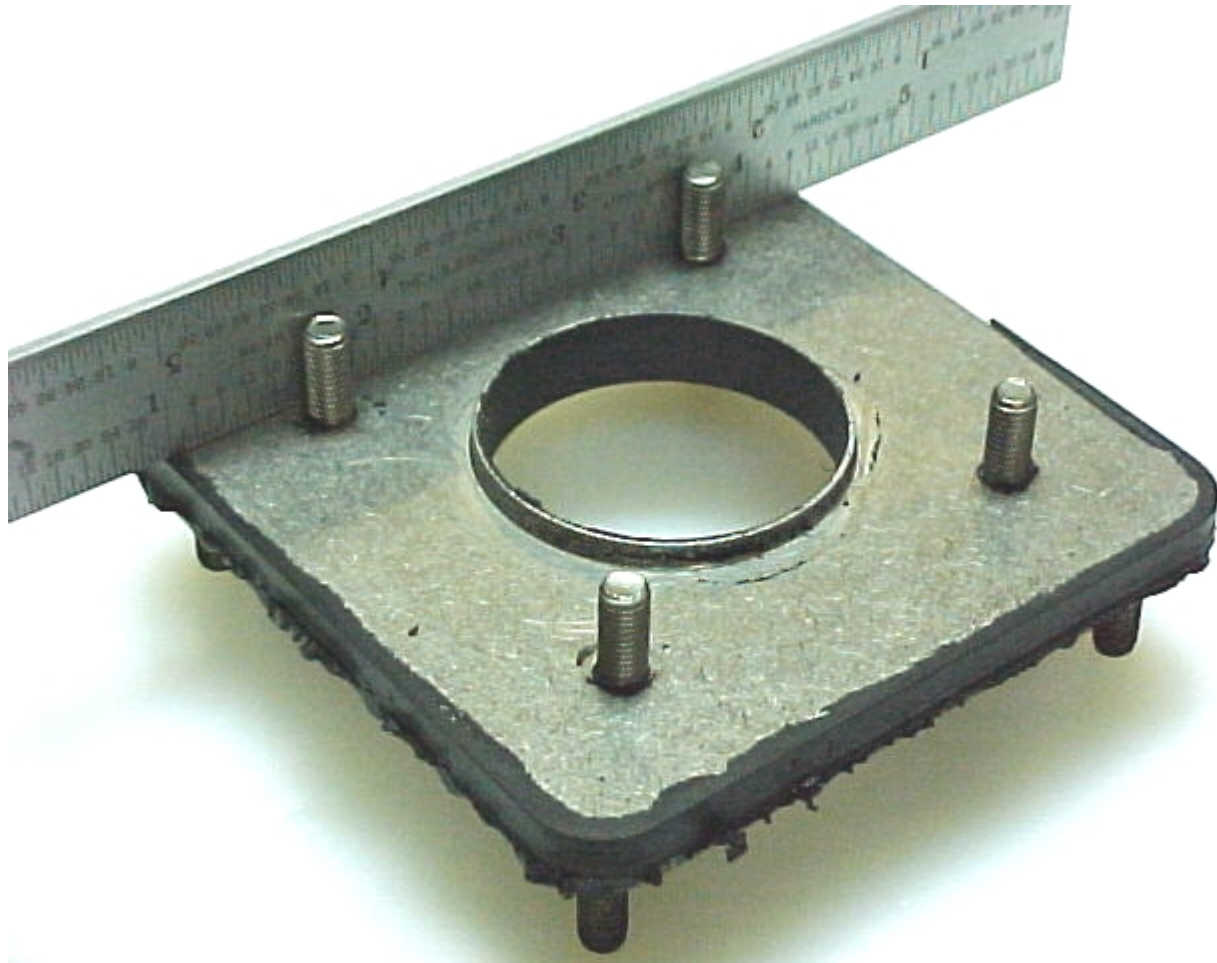
We have found that some of the 645 stepper motor isolator mounts were distorted during the assembly process. This distortion may cause the stepper motor pulley to not align properly with the leadscrew pulley causing premature timing belt failure. If you have repeat timing belt failures on the same actuator, remove the motor isolator and inspect the surface that attaches to the actuator with a straight edge (See drawing below). If the surface around the mounting screws is not flat replace the isolator mount P/N 82756300A.
