# Technical Bulletin

**Mettler-Toledo, Inc.**  
**Scales & Systems**

**Number:** MTFW-03-01  
**Date:** 02-01-01  
**Model:** 647  
**Subject:** 606 Errors

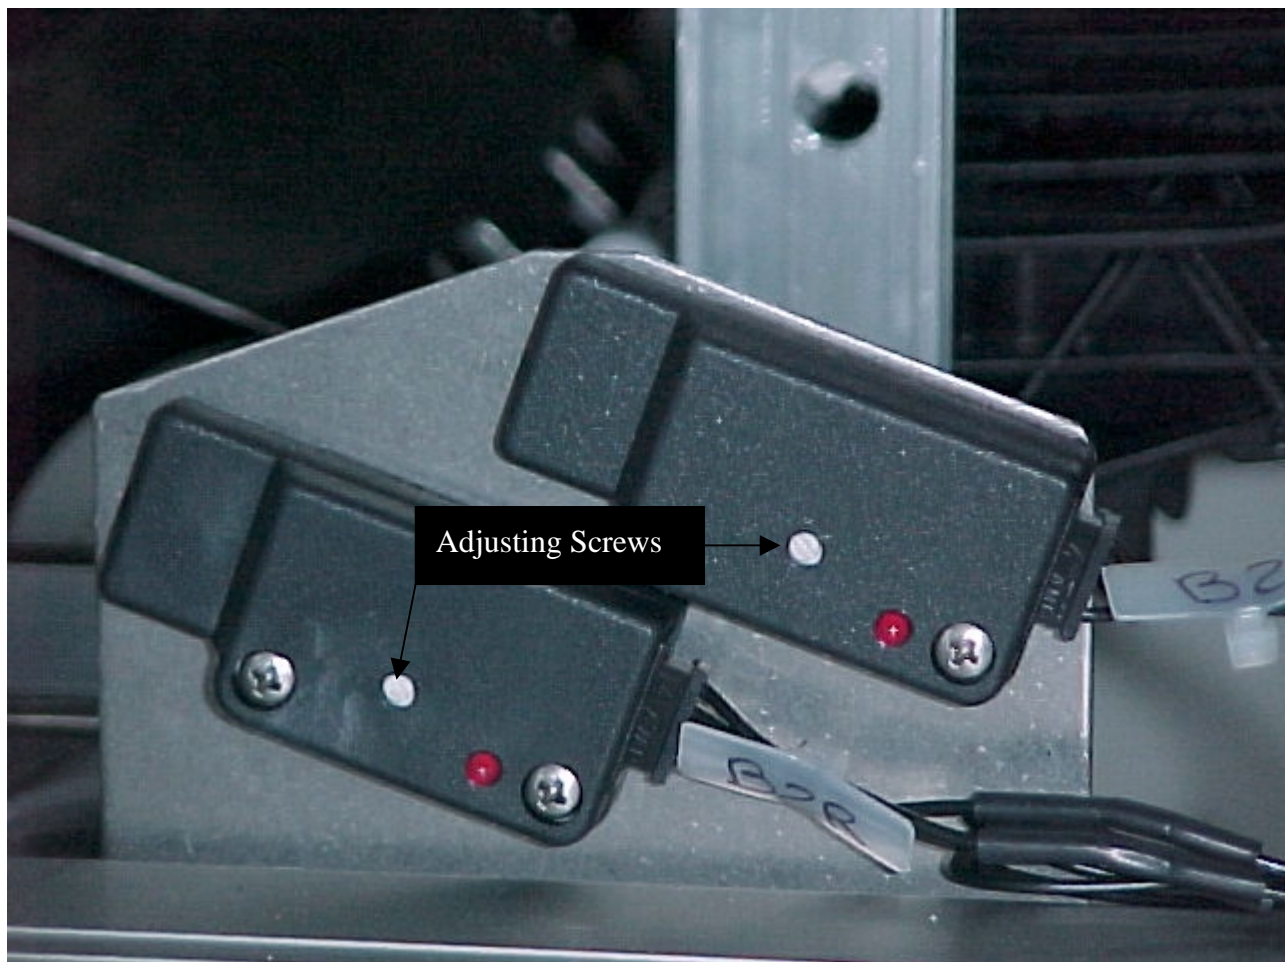
There have been occurrences of 606 errors on 647 Mega and Max wrappers. This error normally occurs when the beams located behind the package lifter are blocked prior to the lifter movement. On the Max Wrapper one of these beams is directed through a hole in the lifter guide rail. If this hole becomes blocked with grease, false triggering may occur. False triggering may also occur due to improperly adjusted gain on the photoeye receivers. The receivers are located on the left end of the wrapper inside the door. To adjust the gain turn the adjusting screw located on the back of the photoeye until the red LED illuminates. This may be clockwise or counterclockwise depending on the internal design of the pot. When the LED illuminates turn the adjusting screw to the extreme in the opposite direction. This will provide maximum gain and minimize false triggering. Repeat the process on the other photoeye.
