# **Technical Bulletin**

Number: 1-17-05

Model: IND310

# **Communications Port Considerations**

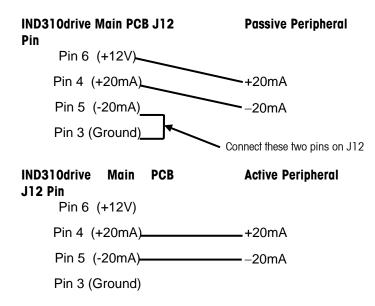
The 20 Milliamp Current Loop on Com 1 is passive. When interfacing to a passive external device such as a scoreboard, you need to supply Voltage to the loop by using the +12V on the port. Below is a diagram showing the wiring to both a passive and active device.
