September 2017

SPS Technical Support News

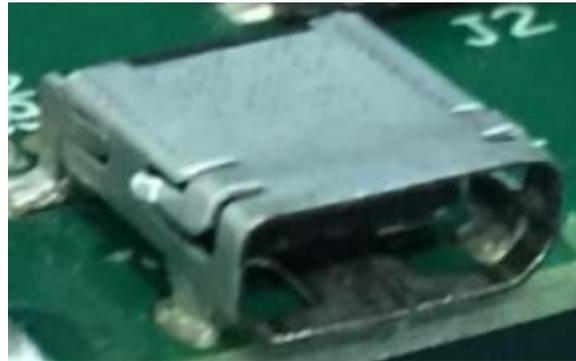
There have been complains about Captuvo USB ports becoming loose over time, hence charging becomes impossible.

Postmortem investigation attributed this problem to an attempt to insert the USB cable into the Captuvo connector upside down. Since the USB cable was upside down the user would inadvertently apply excessive force to insert which would break the internal anchor point of the connector allowing it to be pushed further into its housing. If then the cable was oriented correctly, the pins would not mate and therefore a no charge condition would occur.

Below is a picture of a Captuvo "pushed in port". Notice how far the internal connector has been pushed in.

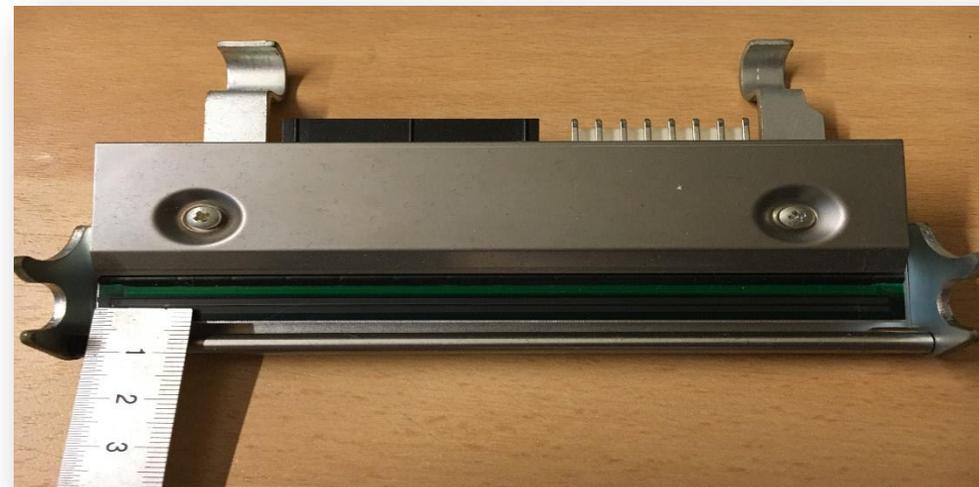
As it can be seen in the picture the dot line is located ~1 cm before the corner edge of the print head.

Best is to clean the head after each printed label roll or ribbon change, but in general no one will do so. Honeywell recommends doing this at least once a week, but it also depends on how many media is printed. Cleaning of the print head can be done with cleaning cards which can be purchased or by using a cotton swab and alcohol to clean the dot line.

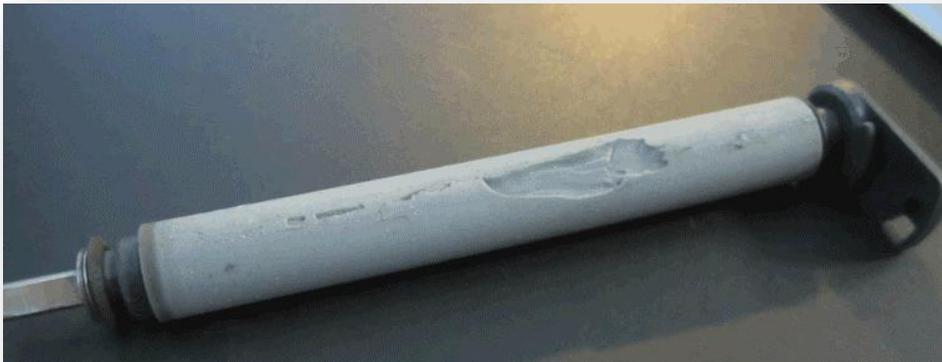
Also what happens very often is that the platen roller for printing have been damaged by the user, or a cutter have been used to separate label from the roller. Maybe it looks like this one and need to be replaced immediately.

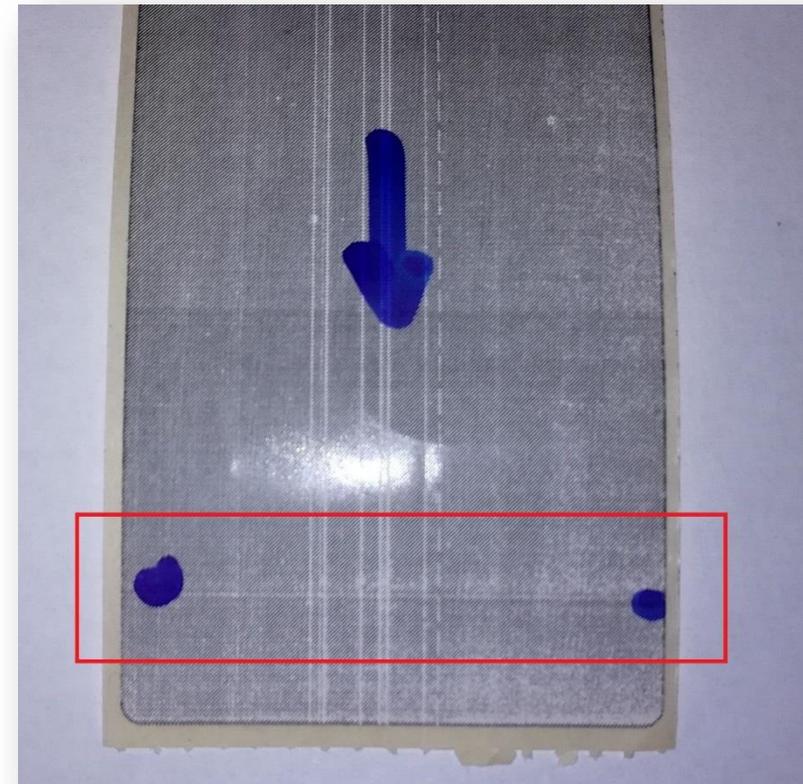
This will cause a print quality similar to this, were the white sharp lines will come from a dirty or damaged print head. If cleaning will not help the print head need to be replaced.
