A TECHNICAL PRODUCT PUBLICATION

## Troubleshooting the SP2000 Printer

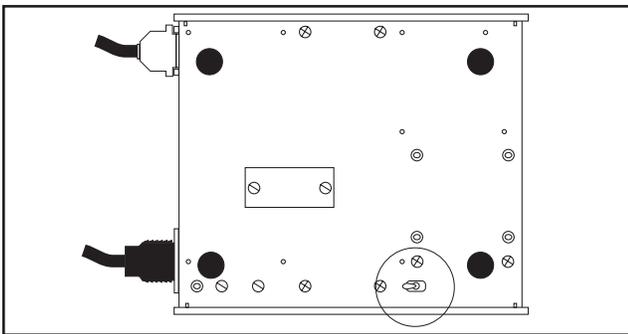
To prevent accidental changes, there is a toggle switch on the bottom of the printer which locks out access to the SET programming switch. This switch is directly below the SET switch. Slide this toggle switch to the rear, and programming the time and date is possible. After setting the time and date, return this switch to the forward position to prevent changes.

SET Switch Lockout on SP2000 Bottom Plate

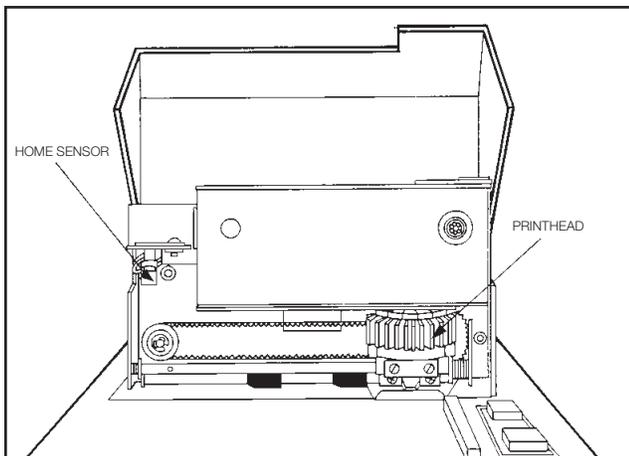
*SP2000 Service Items*

head travel. The first adjustment is the home sensor, an optical switch mounted on a small metal plate located in the upper left-hand portion of the print mechanism. See the above diagram for the home sensor location. The plate is attached to the mechanism with two screws and is slotted to allow side-to-side adjustment of the sensor. By moving this sensor, the point at which the head stops on the left can be changed. This, in turn, changes the point at which the head stops on the right. Experience has shown that the best position for this sensor is where the left edge of the sensor plate meets the left edge of the cutout in the mechanism. Often, this is the only adjustment required.
