# Technical Bulletin

**Mettler-Toledo, Inc.**  
**Scales & Systems**

**Number:** MTFW-14-99  
**Date:** 11-30-99  
**Model:** 645 XL  
**Subject:** New Style Linear Actuators with Plastic One-Piece Nut

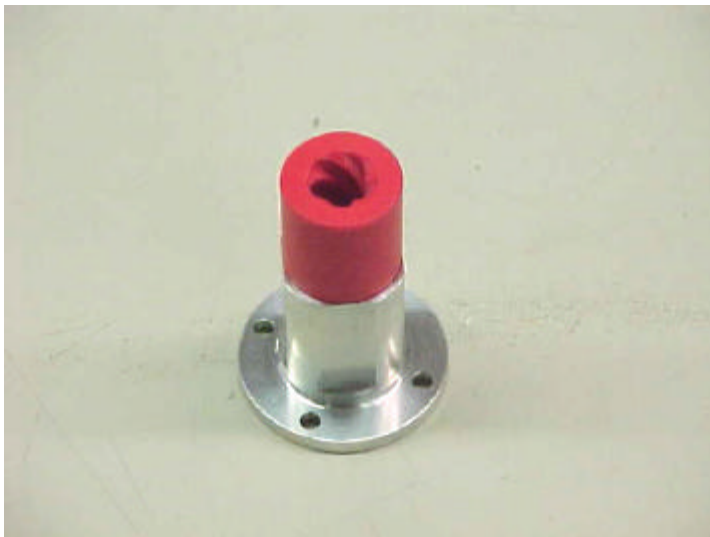
Plastic Nut Assembly PN A82927800A

There have been occurrences of binding on the new style Linear Actuators. To help alleviate this problem the plastic nut has been modified to give a larger backlash. It is also recommended by the manufacturer to **NOT** lubricate the leadscrew. Lubricating the leadscrew causes dirt and other particles to build up in the plastic nut, which eventually causes binding. To fix these problems do the following:

1. Return all existing nuts, PN 82927800A, for credit. Order new plastic nut, PN A82927800A.
2. Remove the leadscrew and carriage from the linear actuator. (Follow disassembly and reassembly instructions below for centerclamp, lifter, and side clamp) Thoroughly clean the leadscrew using a good degreaser such as "Simple Green" (available at your local hardware or grocery store). When the leadscrew is clean, clean it again. Wipe the five grooves on the leadscrew with a rag until all dirt and black grease is removed from the five grooves. Then clean with alcohol.

3. Remove the plastic nut from the carriage and replace with PN A82927800A
4. Clean and regrease the linear actuator case as necessary.
5. For the Side Clamp Actuator Nut Carriage only, apply Teflon tape PN 83066900A to the top of the carriage as shown in Figure 16. The tape prevents the leadscrew shield from scraping and depositing metal chips into the linear actuator.

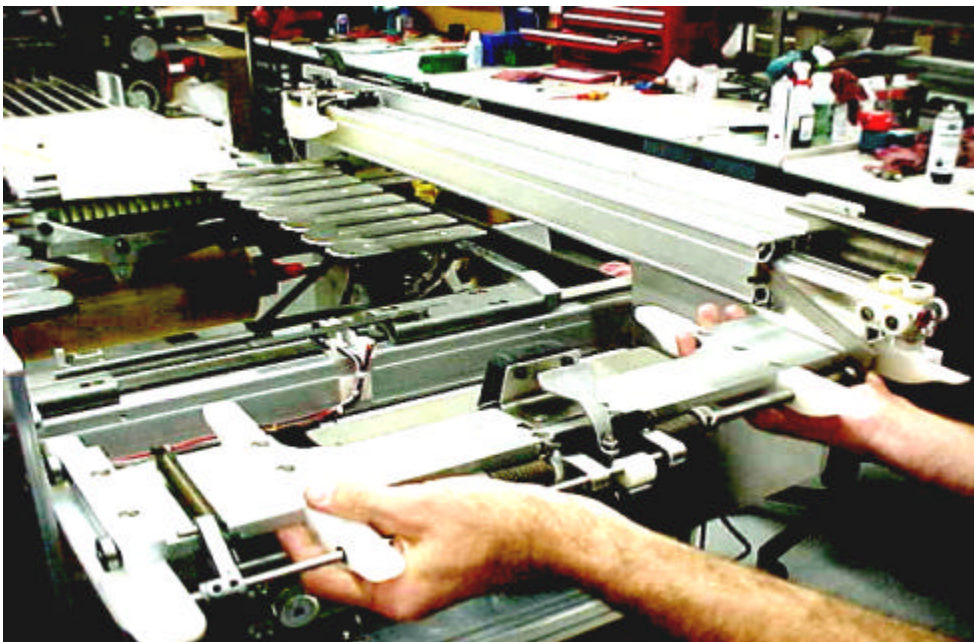
Figure 2

Leaving the centerclamp bolted to the carriage assembly remove both from the end of the actuator case. Figure 2.

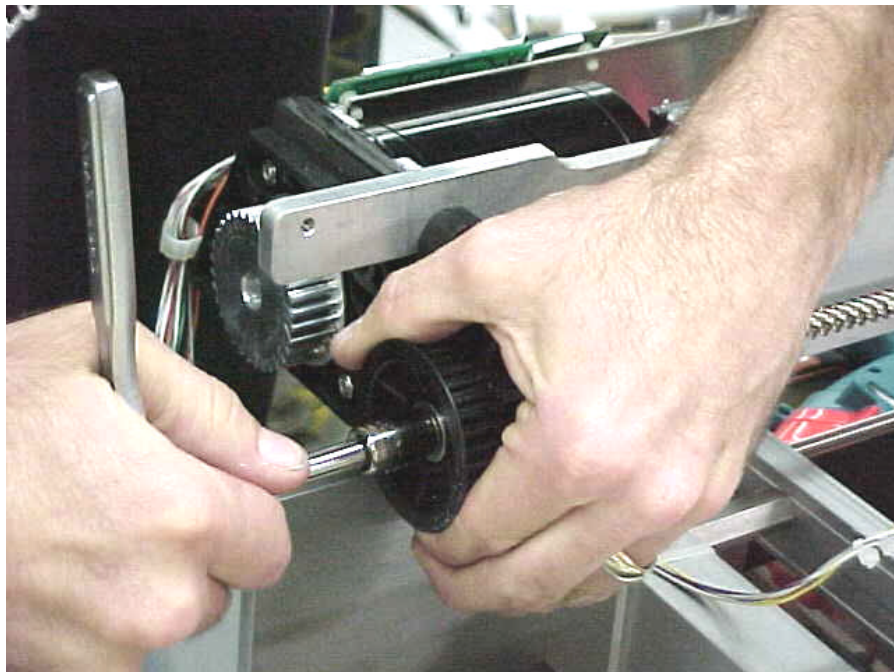
Remove the plastic timing pulley from the leadscrew. Figure 4

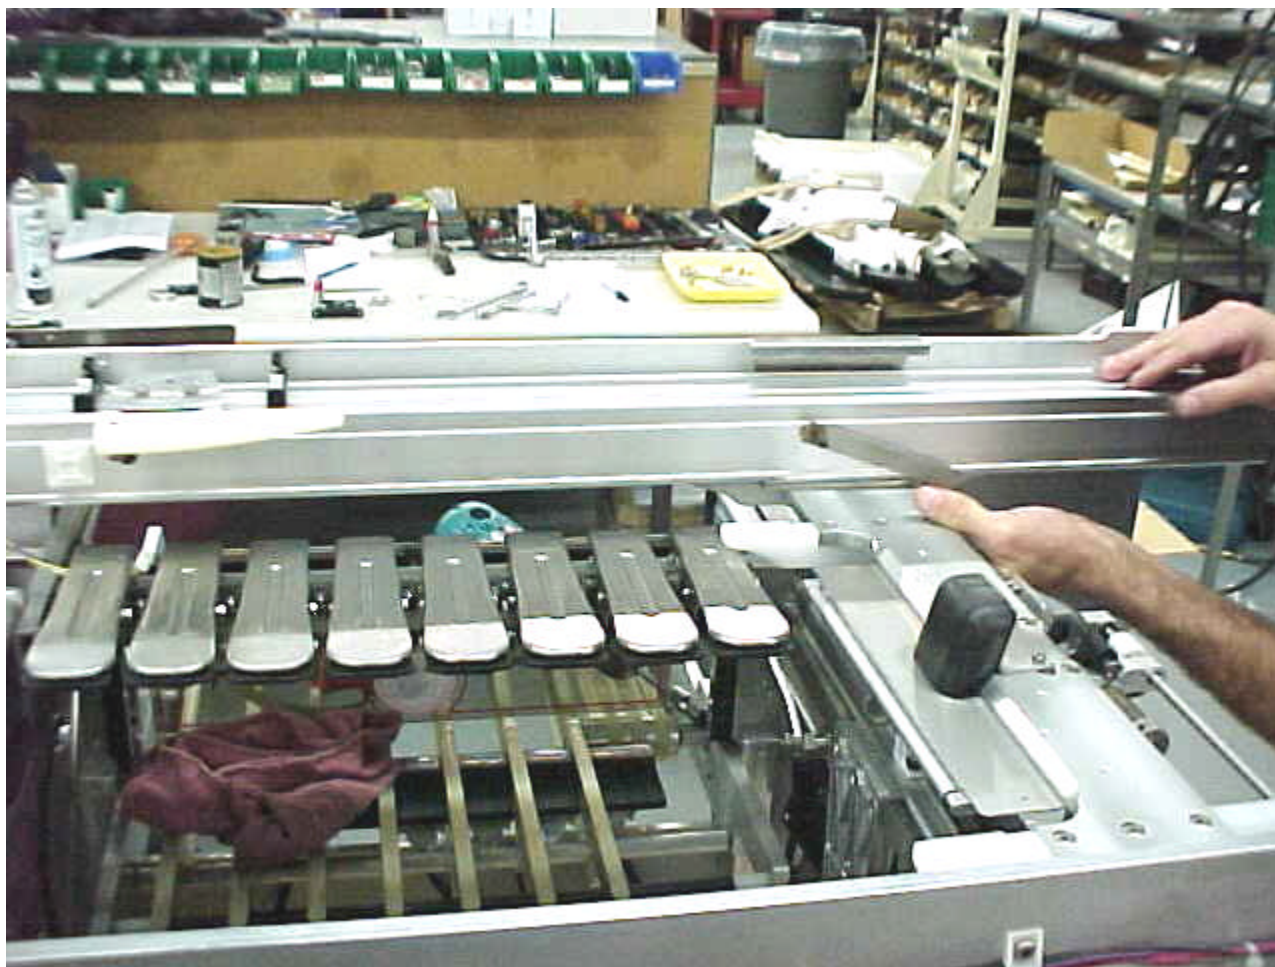
Figure 7

Reinstall case by sliding it over the carriage assembly. Note: this will keep the leadscrew from becoming contaminated with grease. Figure 7.

After reassembling the linear actuator on the machine, perform all checks and adjustments for the Center Clamp section.

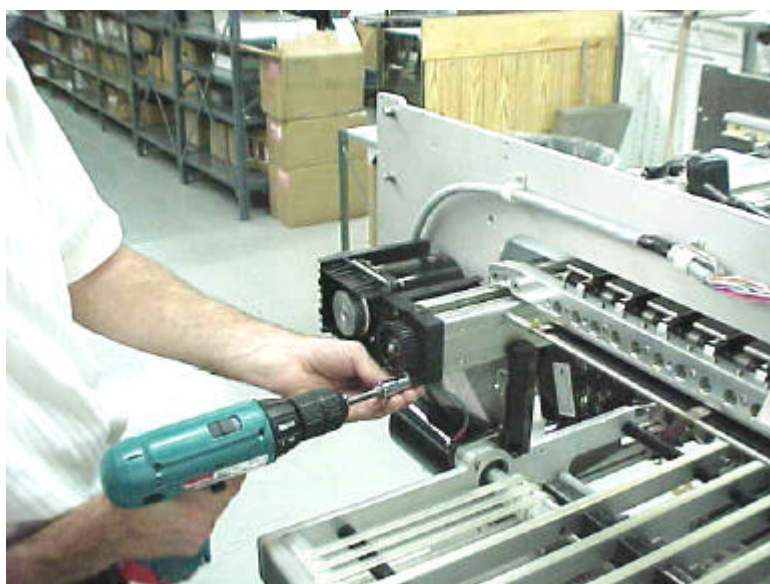
Figure 12

Remove four screws on the motor mount to the case housing. Figure 12.
