September 2017

SPS Technical Support News

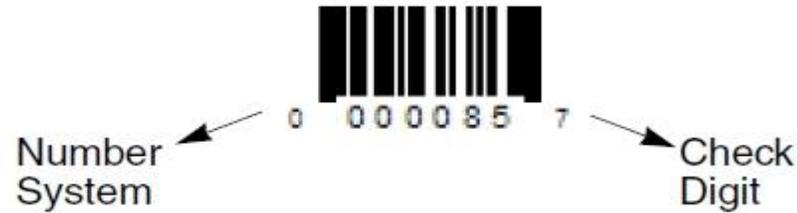
UPC-E0 sample showing the number system and check digit:

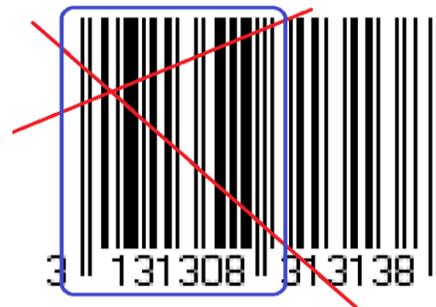
There is a possibility for misread on EAN13, as a laser scanner can read partial an EAN13, when UPC-E1 is enabled

EAN-13 with 31313083133 encoded (Check Digit is 8)

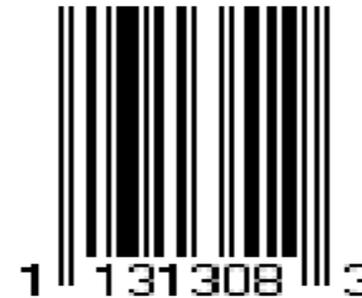
UPC-E1 – no support for Laser Scanner.

UPC-E1 with 1131308 encoded (Check Digit is 3)

Some manufacturers still use UPC-E1 in house crated symbologies, but it is better to read this with an Imager- like the Xenon 1900, Voyager 14X0g series or the Hyperion 1300g. None of Honeywell laser products have ever supported UPC-E1.
