A TECHNICAL PRODUCT PUBLICATION

SP-2000 Printhead Service

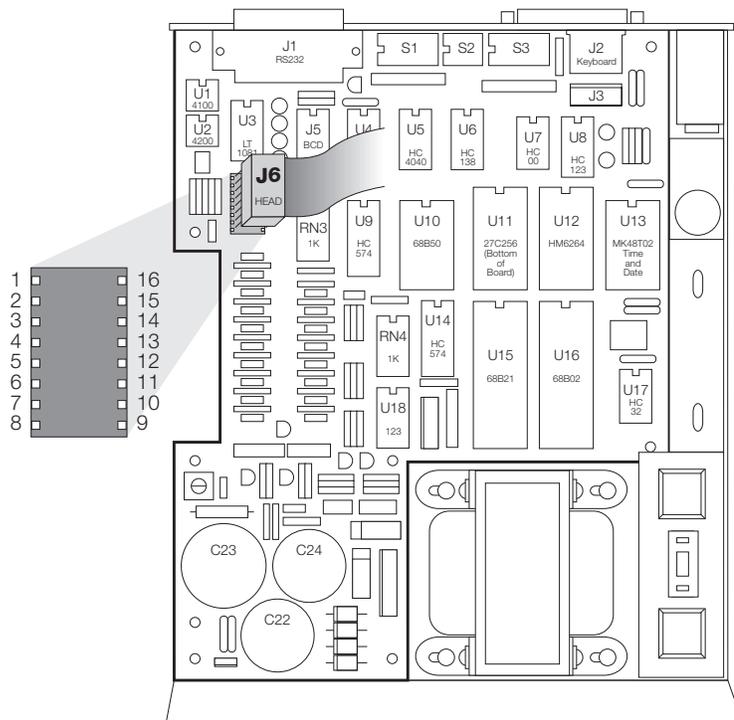
1. Remove printer cover.
2. Remove printhead mechanism assembly and disconnect all cabling.
3. Locate where printhead ribbon cable plugs into J6 connector on main CPU board (see figure below).
4. Apply AC power to printer.
5. Using voltmeter, put positive lead to pin 8 of J6 socket and negative lead to pins 9, 10, 11, 12, 13, 14, 15, 16 and 1.
6. Pins should read between .5 VDC and 3.5 VDC depending on the internal resistance of the voltmeter used. If a pin reads from 5 VDC to 36 VDC, the drive transistor for that pin is damaged and must be replaced.

J6 Pin	Drive Transistor
9	Q3
10	Q4
11	Q5
12	Q6
13	Q7
14	Q8
15	Q9
16	Q10
1	Q11
